**National  
Transportation  
Safety Board**

# Investigative Update of Battery Fire Japan Airlines B-787 - Jan 7, 2013

*February 7, 2013*

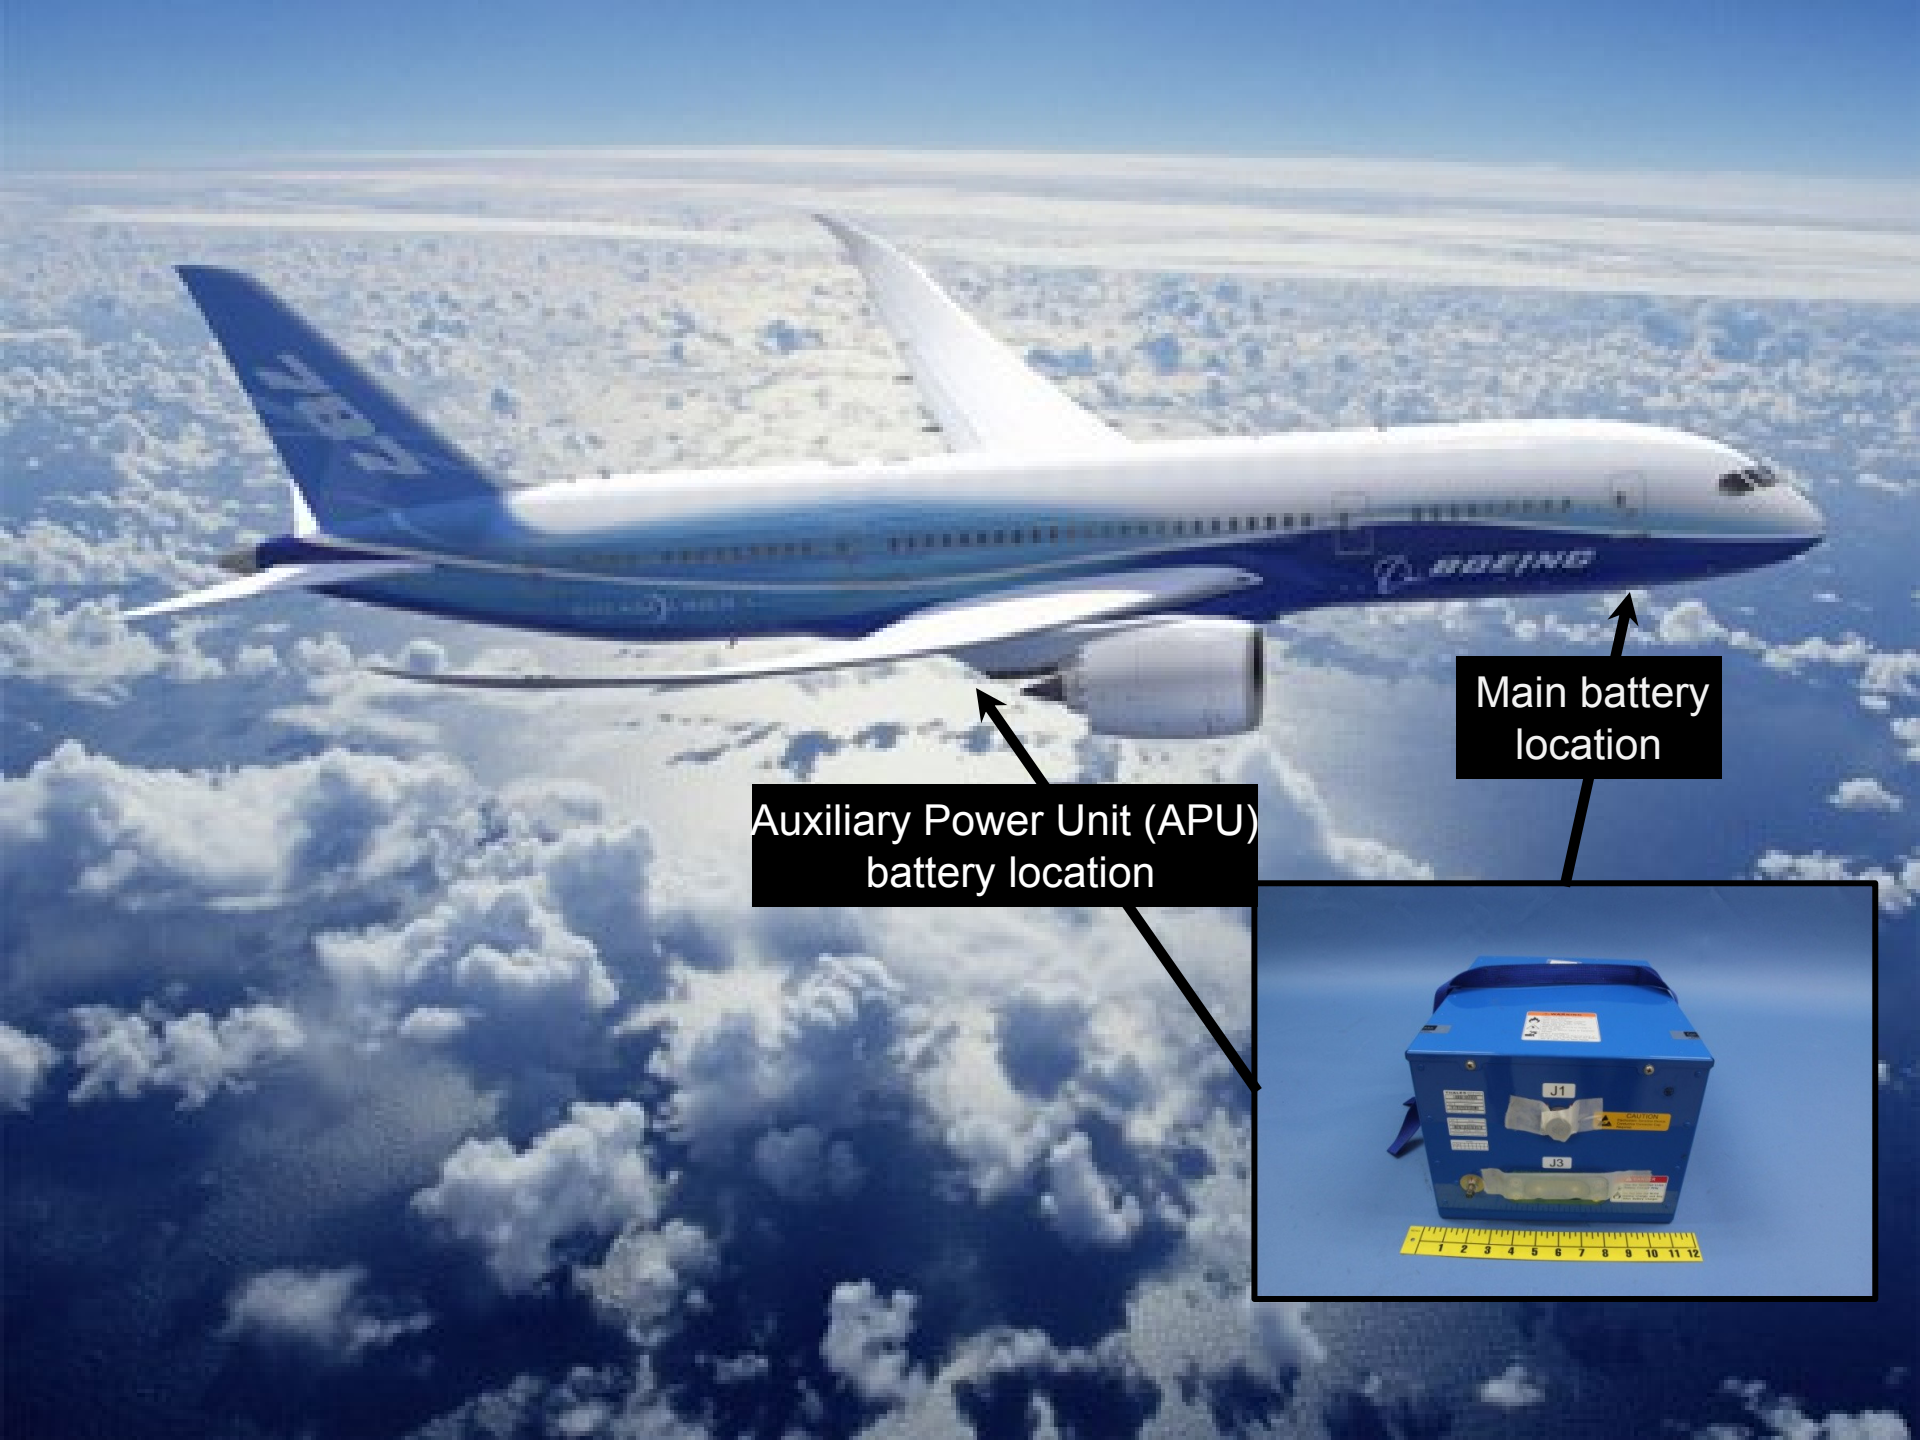
Auxiliary Power Unit (APU)  
battery location

Main battery  
location

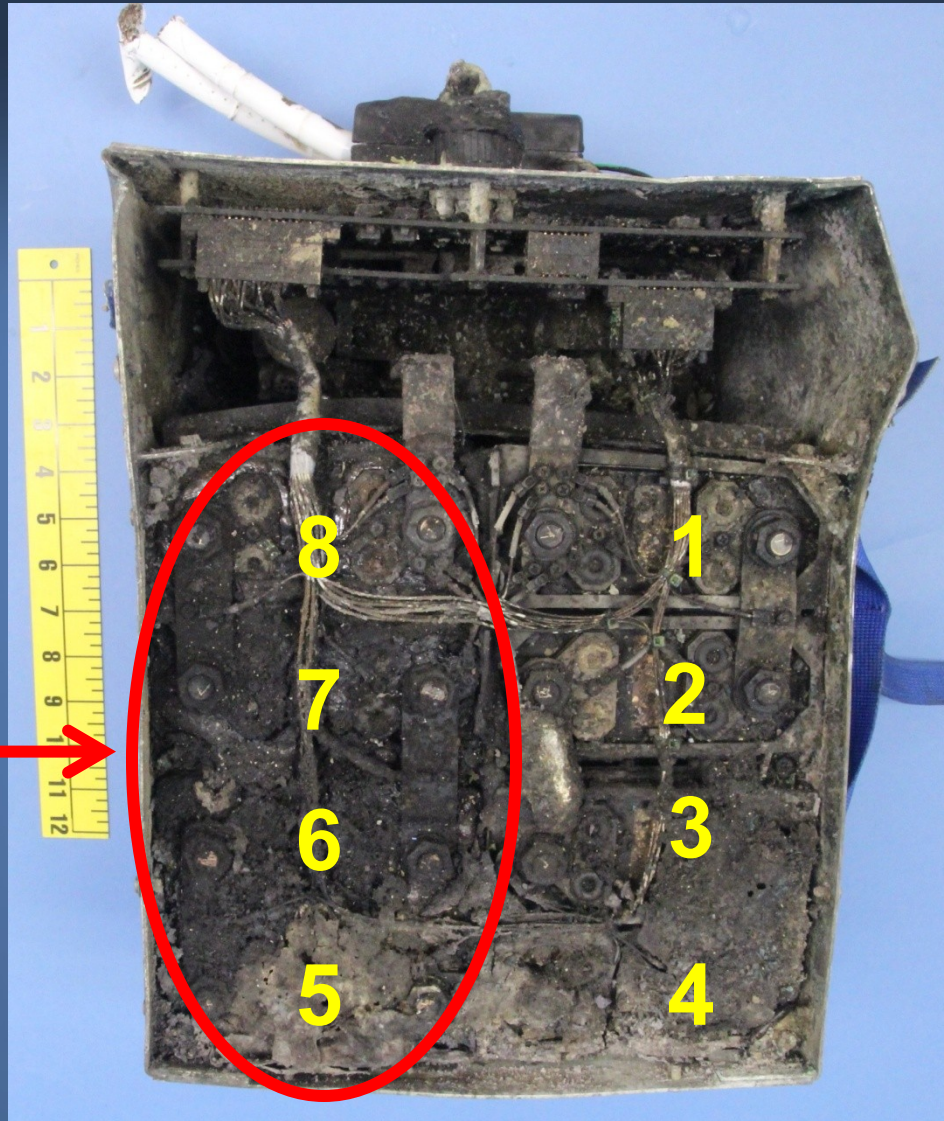
Area of  
most  
thermal  
damage

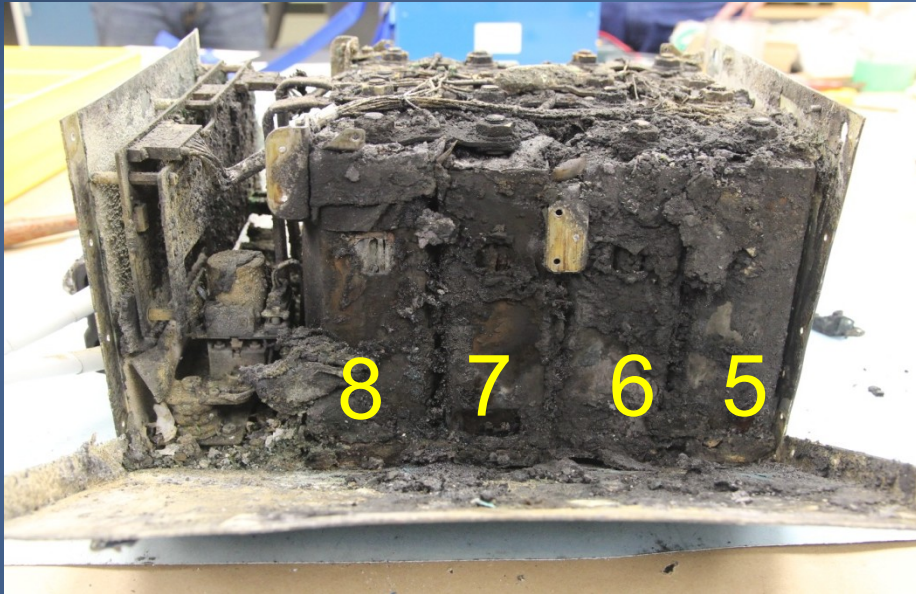
Cells on the left side

Substantial thermal damage

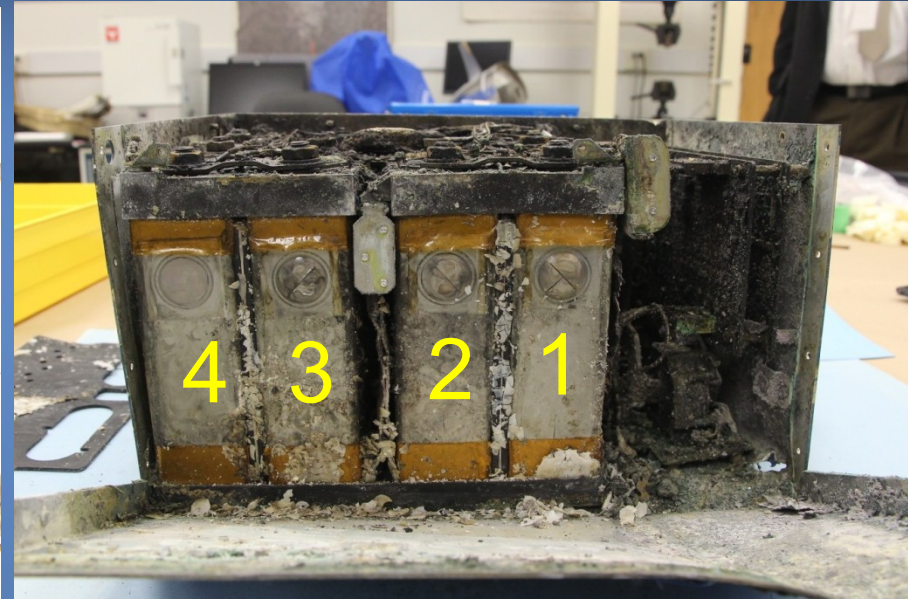
Cells on the right side

Moderate thermal damage

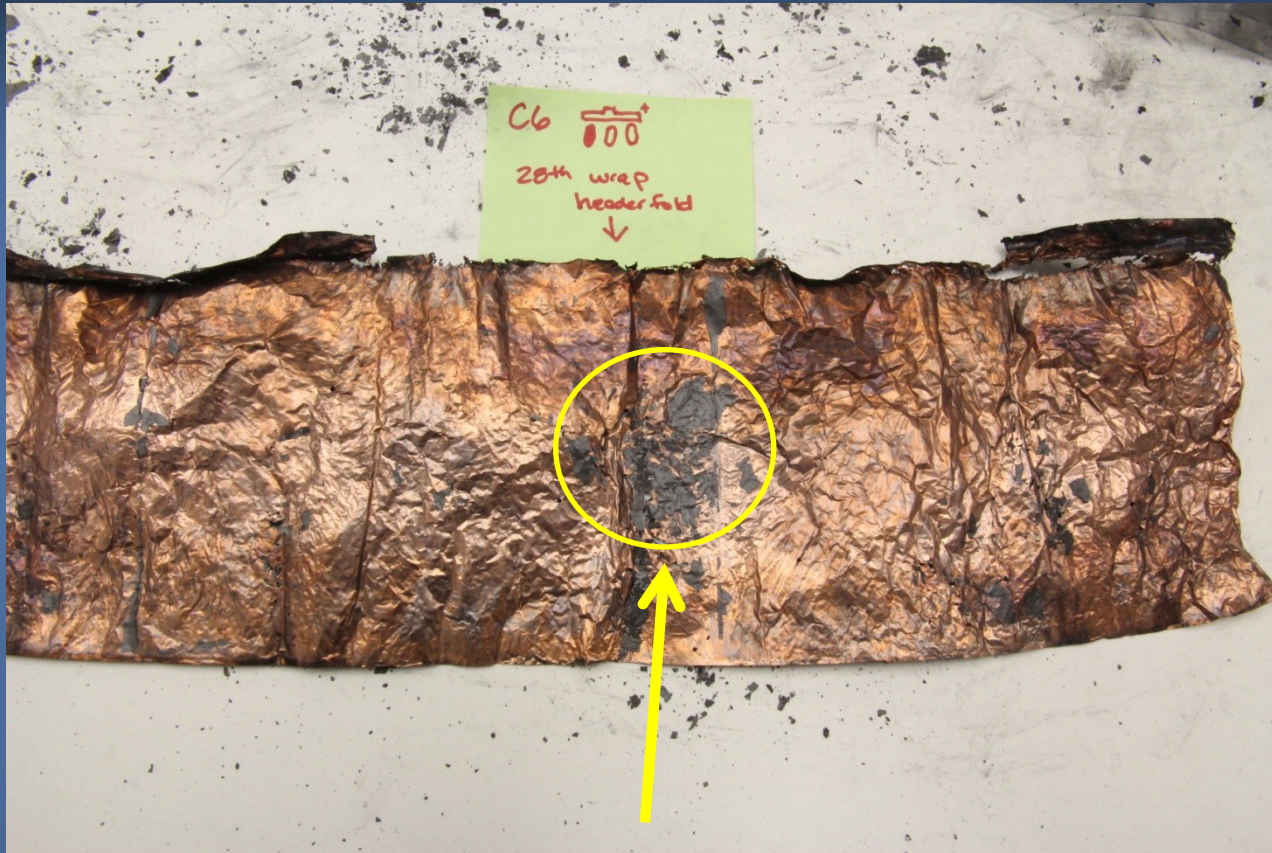
# Damaged electrode in Cell #6

Hot Spot

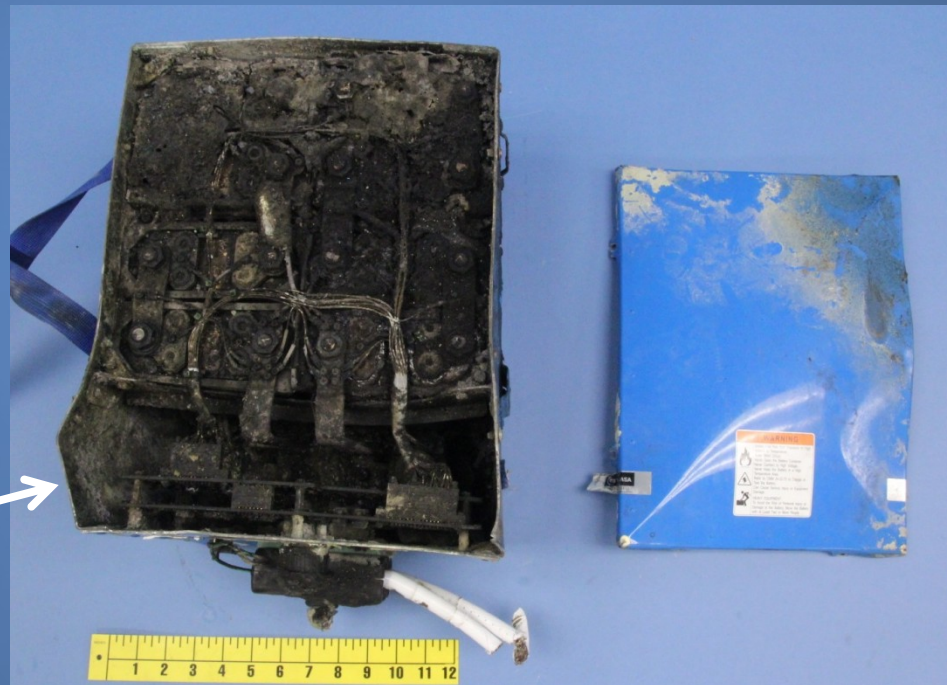
- Mechanical impact damage

Damage from  
firefighting  
efforts

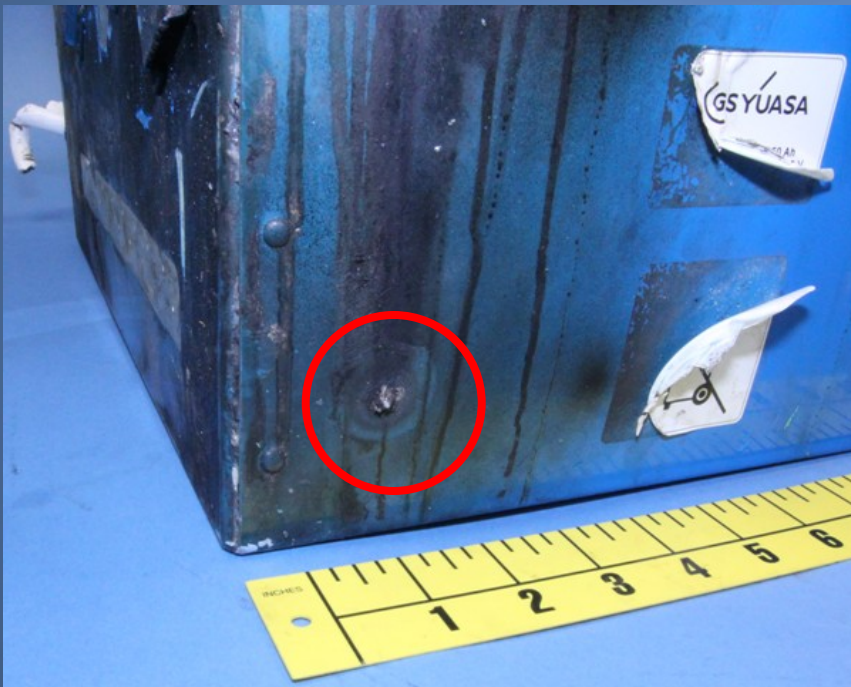
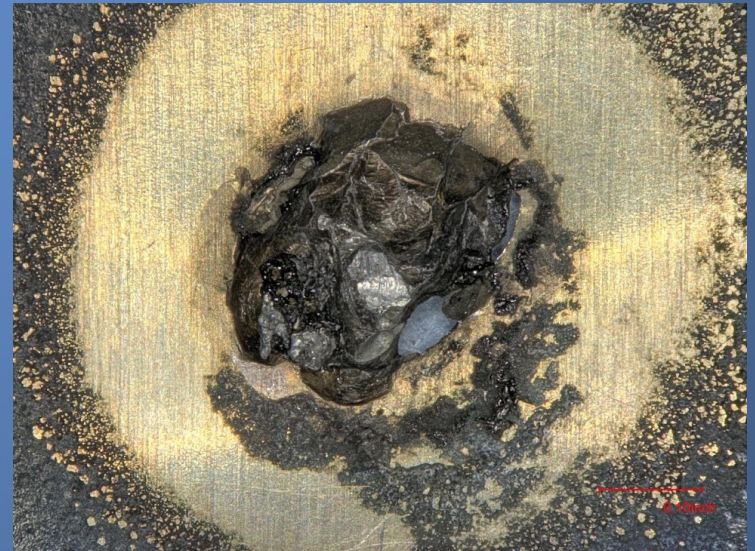
Viewed From Outside  
(Post-clean)

- External short circuit of cell or battery
